# António Mário Almeida<sup>®[1]</sup>, Mário António Pereira<sup>®[1]</sup>, Graça Vasconcelos<sup>®[2]</sup>, Salomé Carvalho<sup>®[3,4]</sup>, Rui Bordalo<sup>®[4]</sup>, Eduarda Vieira<sup>©[4]</sup>

#### Abstract

UPV, Sculpture, Plaster, Conservation, Museum, Soares dos Reis.

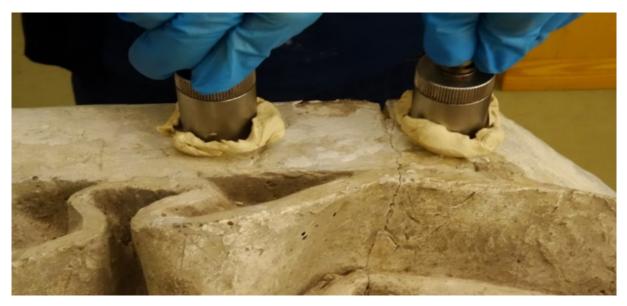
There is also a visible fracture at the base for which consolidation has been attempted in the past, but the fracture persists as no signal goes through it (Figure 6).

**Figure 6** – A fracture at the base that has been repaired, but the signal is not transmitted through it. The white stain visible on the surface and inside the fracture is part of the repairing material.

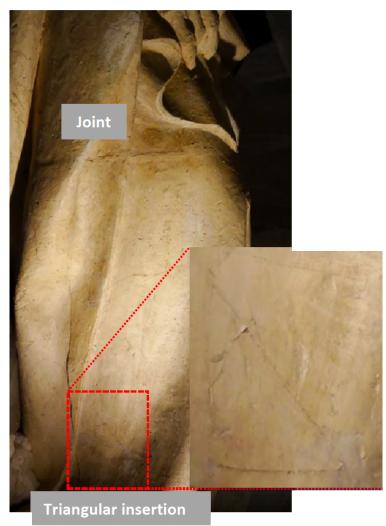
The two points framed by the green box are from a larger set of measurements along a strip on the front part that crosses a joint and includes a small carved triangle-shaped incision (Figure 7). The signals measured through the joint are regular but, unexpectedly, those through the triangular shape revealed to be tricky. That triangular incision seemed to be a superficial mark, casually made by someone, but the long ToF measurements indicate that it is an insertion filled with a material different from the original plaster or whose bonding may not have been well consolidated.

Figure 7 – The ultrasound waves do not propagate across the triangular insertion but they do through the joint.

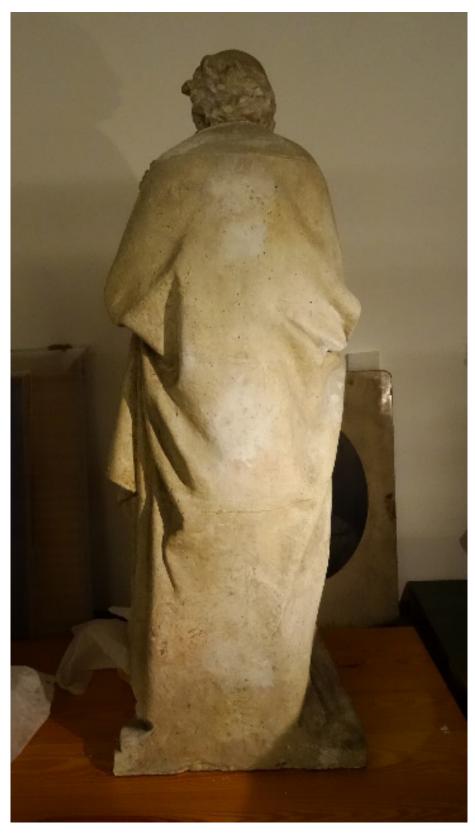
All other values under 2000 m/s are from the back, where a few large spots have been repaired with some unknown material. In Figure 8, a clear contrast can be seen between the original plaster and the surface additions. In these cases, the ToF measured across original plaster and repaired areas was systematically long.

**Figure 8** – The transmission of ultrasounds across the brighter areas is reduced and, in some cases, can only be achieved with the lower frequency of big transducers.

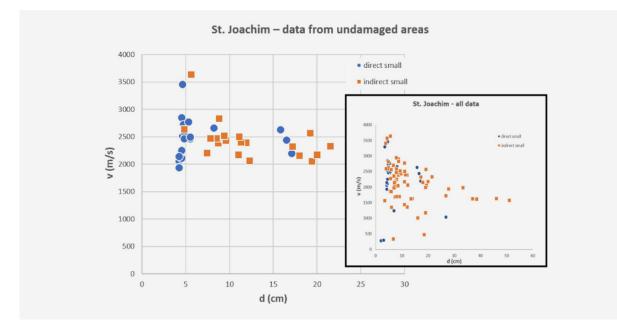
A few repairs with a cement-like material at the base and at one folder of the clothing, yielded velocity values above 3000 m/s. Conversely, measurements through a visible crack at the base gave velocity values under 2000 m/s, suggesting that the crack may not be consolidated, although it appears to be partially repaired on the inside (see the inset in Figure 9). If these repair materials are alike or different from others already found, this can only be verified by taking samples and analyzing them.

Putting aside these abnormal values from the measurements, the remaining values are represented in the main plot of Figure 9, and all but two are within the range of 2000 to 3000 m/s. These two were obtained at the same location, in another fold of the cloak very close to a joint, where both direct and indirect measurements were possible to obtain. Further inspections on this particular site are required to find the reason for these high values of the velocity.

**Figure 9** – St. All the data from St. Joachim collected are shown in the insertion picture. The main plot does not show the points collected at damaged and repaired areas identified by visual inspection.

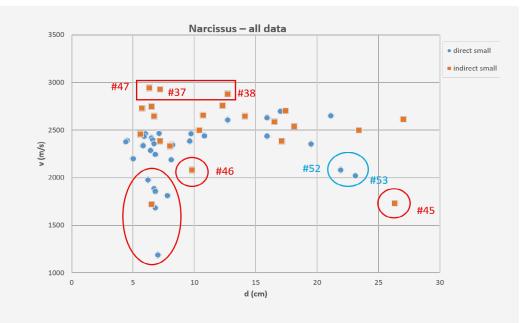
Surrounded by a red ellipse, a few direct measurements on the right leg were troublesome to obtain and the calculated velocities were very low. These results led to a visual inspection and a thin long horizontal crack was found in the interior part of the right thigh. An indirect measurement was taken at this site, with the crack between the transducers, resulting in the orange square displayed in this dataset.

Points #52 and #53 are direct measurements taken between the hips. The lower values of the velocity are due to the internal void, which makes the waves travel a longer path that the distance measured between the transducers. This void is to be expected, as the front and back were cast separately and then joined together, leaving a hollow space between them.

Figure 10 – Data collected from Narcissus, with a few highlighted points that need to be discussed.

This artwork appears to be in very good state of conservation, except for the right leg, where a few cracks are visible in the internal and external sides. To determine whether these cracks are related, further mechanical analysis is recommended.

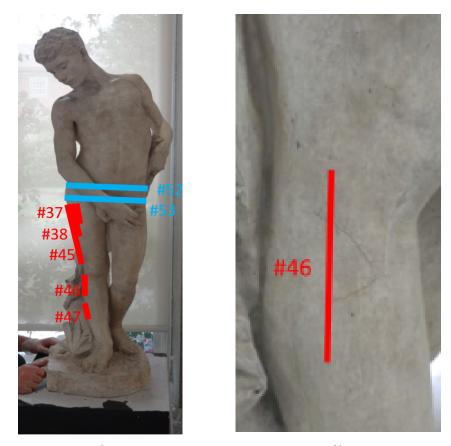
The indirect measurements taken on the outside of the right thigh, fixing one transducer and displacing the other (Figure 11a), gave regular results except the last one (measurement #45), which was taken through another small crack on the surface.

Point #46 corresponds to an indirect measurement through a V shaped mark on the surface, below the right knee (Figure 11b) and is one of the lowest values of velocity.

a) b)
Figure 11 – Highlighted data points from Narcissus
(a); data point #46 was measured through a V shaped mark (b).
