# António Mário Almeida<sup>®[1]</sup>, Mário António Pereira<sup>®[1]</sup>, Graça Vasconcelos<sup>®[2]</sup>, Salomé Carvalho<sup>®[3,4]</sup>, Rui Bordalo<sup>®[4]</sup>, Eduarda Vieira<sup>©[4]</sup>

#### Abstract

UPV, Sculpture, Plaster, Conservation, Museum, Soares dos Reis.

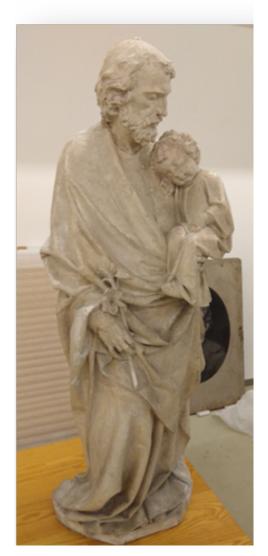
**Figure 2** – St. Joseph (1880), Soares dos Reis, plaster, height: 172cm, width 70 cm, depth 46 cm. Museu Nacional Soares dos Reis, Porto, Portugal. Inventory sheet: http:// www.matriznet.dgpc.pt/MatrizNet/Objectos/ObjectosConsultar.aspx?IdReg=309247

Even though these pieces present a satisfactory conservation state, suitable to be publicly exhibited, a first visual inspection has shown some damage to their bases, such as fractures repaired with some kind of hard cement. St. Joseph also shows a few scratches on the front side and some areas with a slightly different colour on the backside, denouncing superficial restorations. St. Joachim has some superficial restorations in the front and Narcissus has some damage to his right leg. There are no records of previous damage identification, reparation works or materials used for any of these plasters.
