Ethnographic artifacts are intrinsically fragile, due to the natural constituent materials degradation. A polychrome and polymateric ethnographic shield from Borneo, owned by the National Prehistoric Ethnographic Museum "Luigi Pigorini" in Rome, has been carried out to restoration regarded mainly the painted surface cleaning and the feathers recovery, following criteria such as adopting not invasive methods to preserve the original materials and using eco-sustainable products.

The paper describes the conservative intervention of an ethnographic polychrome and polymateric artifact, a ceremonial shield coming from Borneo island and made at the end of the 19th century (Figure 1). The shield is made of natural materials: wood, pigments and binder, feathers, different types of vegetable fibers and bamboo. Over time, these materials have degraded, in particular the painting layers, feathers and the plant fibers. The conservative restoration required targeted actions on each material by adopting specifically designed operations.

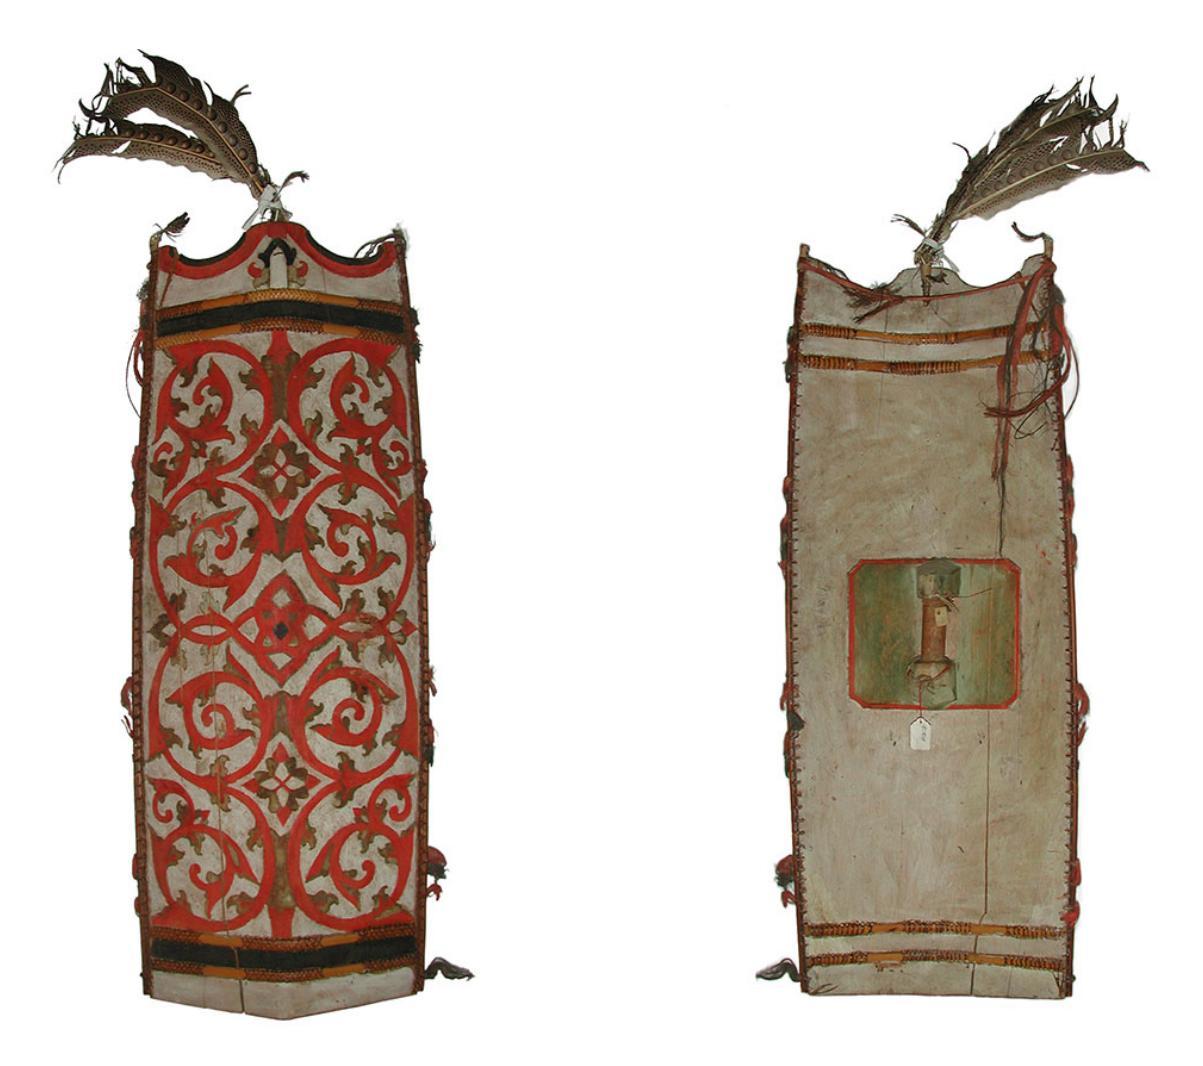
The artifact, a single rectangular block wooden sculpture and convex externally, is polychrome and multi-materic: the structure is in wood while the decoration is made of pigments and binder, different types of plant fibers, feathers and bamboo (Figure 1). The wooden structure is *dyera costulata* species, an arboreal plant present in the Borneo forest (Theissen, 2016).

Figure 1 – Front and back side view of the "Dayak ethnographic shield.

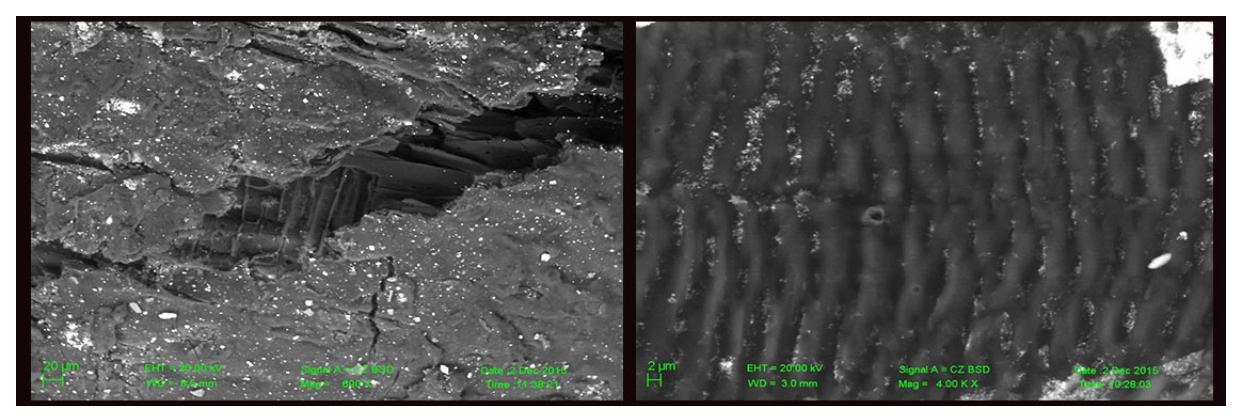
Figure 2 – SEM images of the *dyera costulata* wooden substrate: the low magnification micrograph (left) shows the highly irregular surface, at high magnification (right) the porous structure of the wood is highlighted.

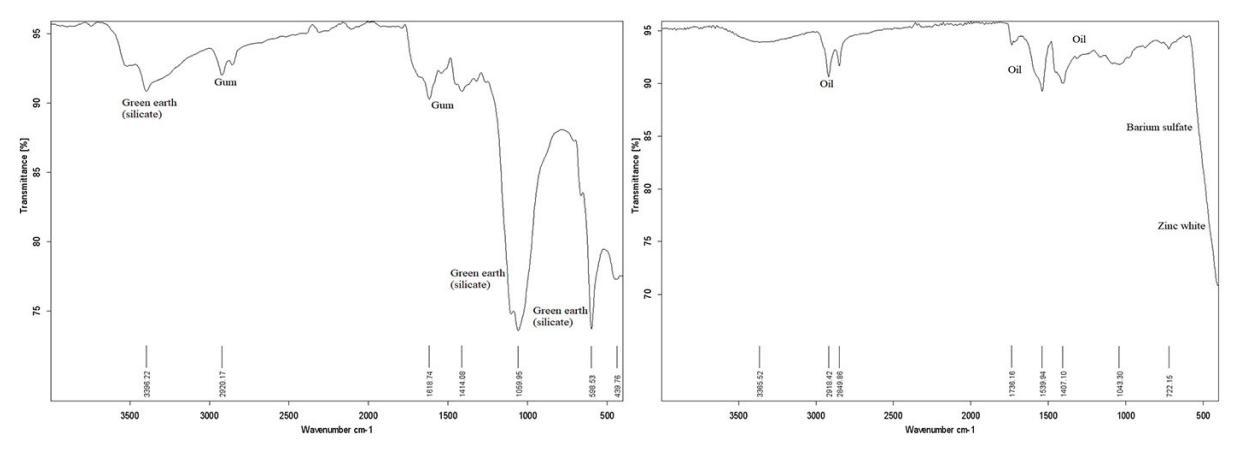
In order to identify the nature of pigments and binders, a characterization campaign was conducted on micro-samples taken from the paint film. The samples were analyzed by SEM-EDS, FTIR, and Raman spectroscopy¹. The pigments identified were: zinc white (zinc oxide ZnO), vermillion (mercury sulphide HgS), lamp black (elemental carbon with O, H, S and various impurities) and green earth (silicate-earthy compounds). Different binders were used for the pigments: oil for the white and vegetable gum for the other pigments. The vegetable fibers were observed by SEM, whereas the colours were analyzed by FTIR (Figure 3) and by SEM with the aid of EDS probes (Figure 4) - i.e., vermillion for red and lamp black for black (Bevilaqua, Borgioli, & Gracia, 2010).

Figure 3 – FTIR spectroscopy of the green pigment sample - green earth - with gum binder (left) and of the white pigment sample - zinc oxide - with oil binder (right).

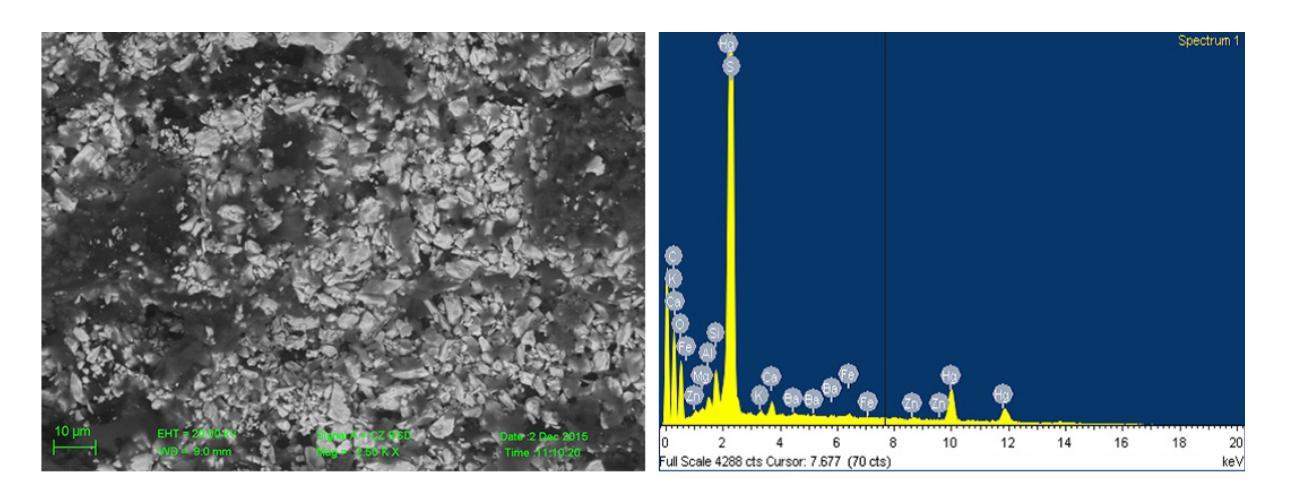
Figure 4 – SEM image recorded and qualitative and partially quantitative EDS micro-analysis of the white pigment sample. From the analysis the presence of zinc (Z), oxygen (O) barium (Ba) and sulfur (S), due to zinc white (zinc oxide) with percentage of barium sulfate, is detected.

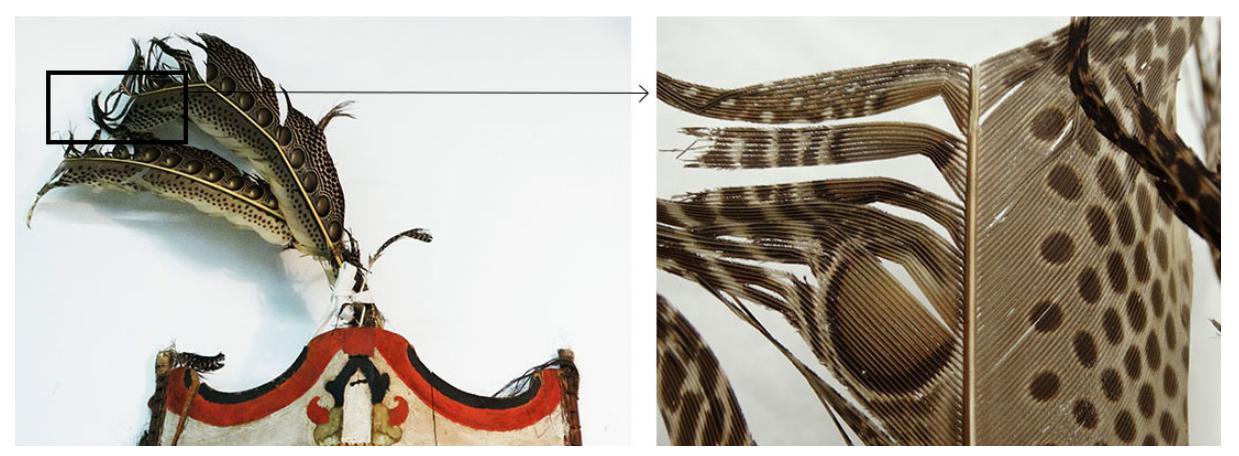
The whole surface of the shield was dirty due to sedimented dust. In particular, the background white was the dirtiest paint since it was formed by oily binder². The composition of the feathers was in a bad state of conservation (Figure 5). The higher degradation was structural due to the broken rachides and quills in different areas. The barbs and the barbules were broken, depolymerized, uncombed and dirty due to dust. Finally, the tufts of vegetable fibers on the sides of the shield were dehydrated, broken, tangled together and subject to shattering already at the slightest mechanical stress.

Figure 5 – Feathers state of conservation: feathers composition with broken rachides (top-left), terminal part of a broken rachis and mechanical disorder of the barbules (top-right).

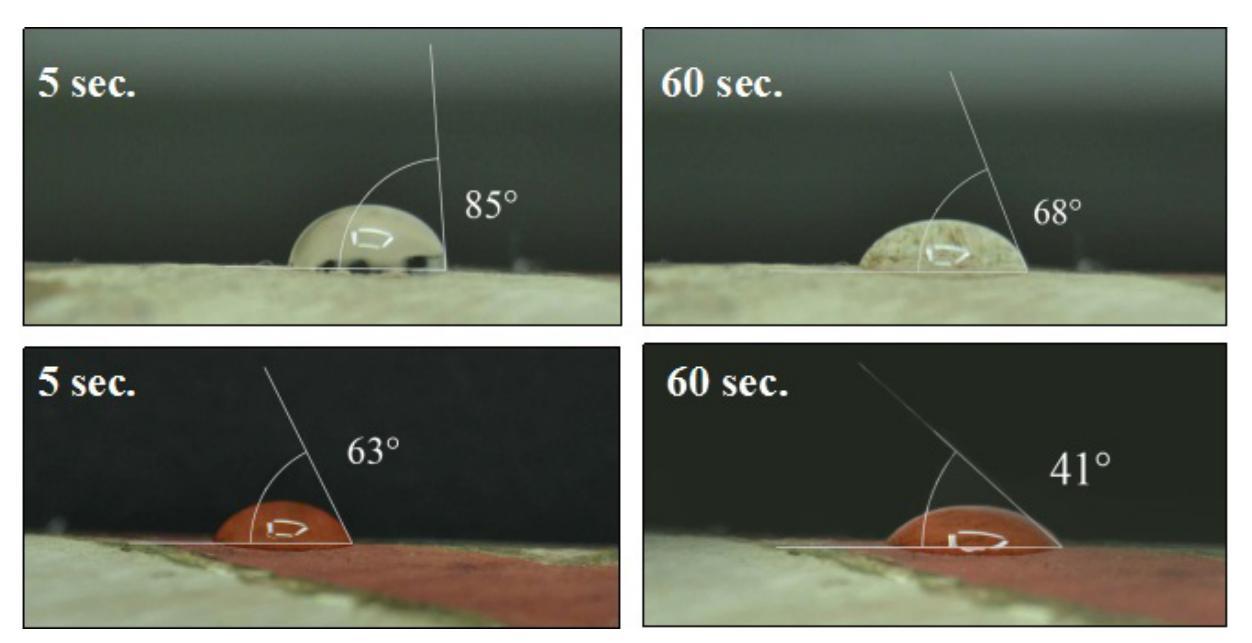
³ The contact angle measurements on the white background showed a partial wettability with an average high contact angle of 83° in the first 5 seconds and of 68° after 60 seconds). Therefore, the observations showed that the white paint film was hydrophobic due to the 90° contact angle, unlike the red and green backgrounds that were more hydrophilic.

Figure 6 – Time evolution of white (top) and red (bottom) paint contact angle.

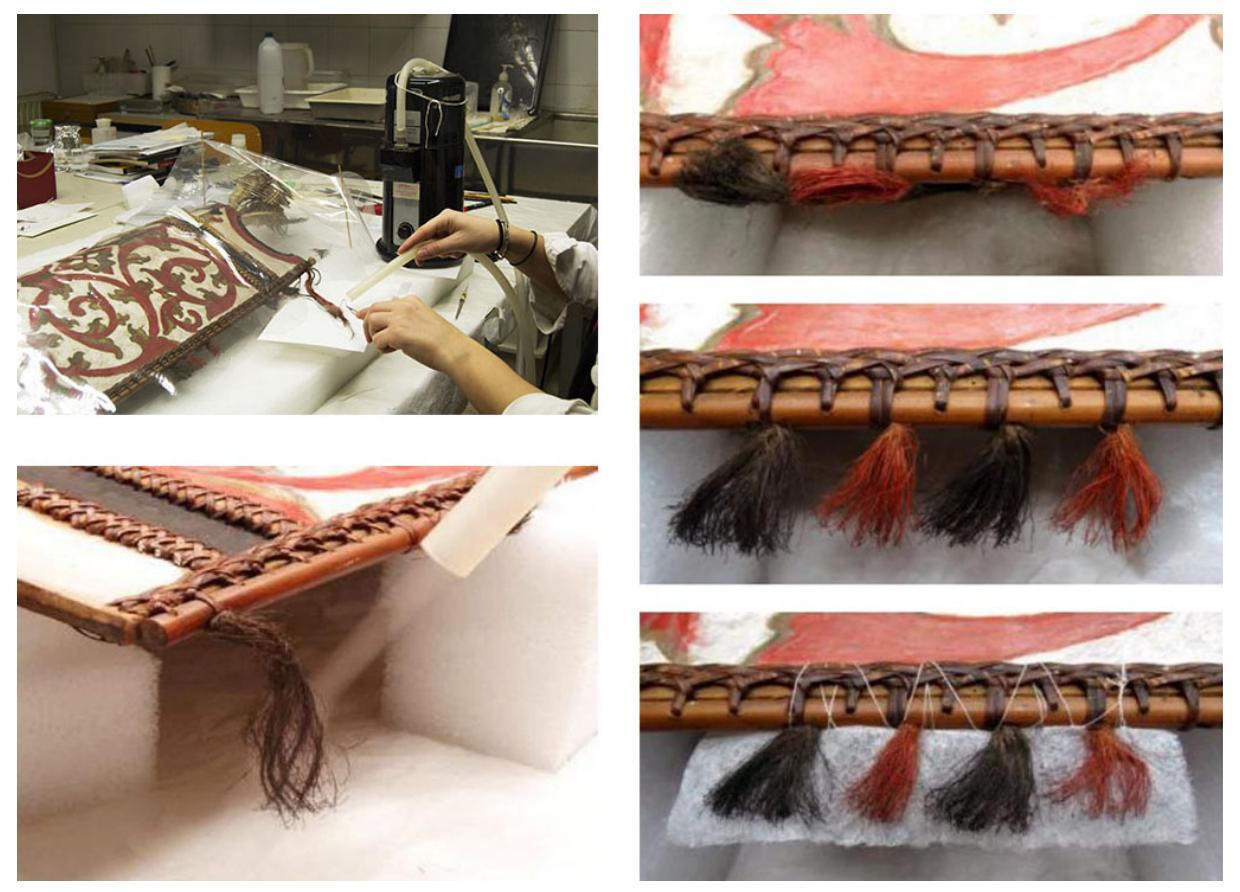
Figure 7 – Treatment of hydration performed on the vegetable fibers by an ultrasonic vaporizer and their protection with Japanese paper.

The first operation was the intervention on the fibers. They had been rehydrated and disentangled through humidity by an ultrasonic vaporizer⁴. The minimum amount of humidity generated by the instrument was evenly distributed over the fibers to allow the gradual absorption of water within the cellulose structure of the fiber. The fibers knots were untangled by means of thin-tipped pliers, thus the dirt between the fibers was removed.

After this operation, it was possible to consolidate the fibers (Figure 7). We needed a product able to give both strength and flexibility to the fragile cellulosic structure, being chemically stable and with good viscosity for a better penetration (Barclay, 1986). The polymer poly-ox-azoline (Aquazol® 200) dissolved in demineralized water had been selected and applied by means of ultrasonic mister, preceded by a humidifying treatment in order to convey the solvent. Finally, the fibers had been protected with Japanese paper.

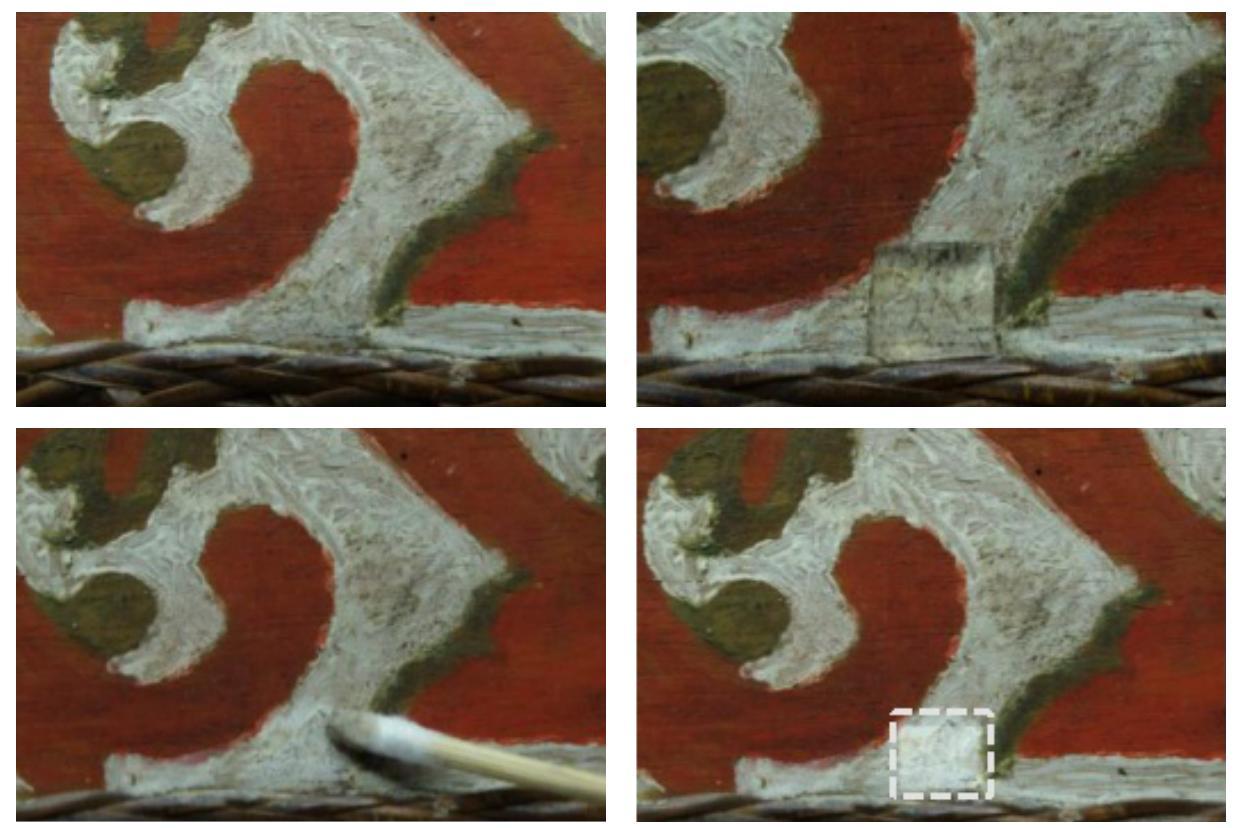
Figure 8 – Tests of Gellan® gum over paint layers.

After the consolidation, it was possible to clean the white paint. Four solvents with different polarity had been tested⁶: water gave the best results. However, as the mechanical action by swab induced stress to the surface paint, rigid gels had been selected. In particular the Gellan® gum⁷ was taken in consideration and chosen for its excellent properties, such as the controlled release of water and the total transparency of the gel (Iannuccelli & Sotgiu, 2012). The contact angle test determined that the white paint medium was highly hydrophobic. Therefore, it was chosen to use Gellan at 4%^{8,9} concentration (Figure 8).

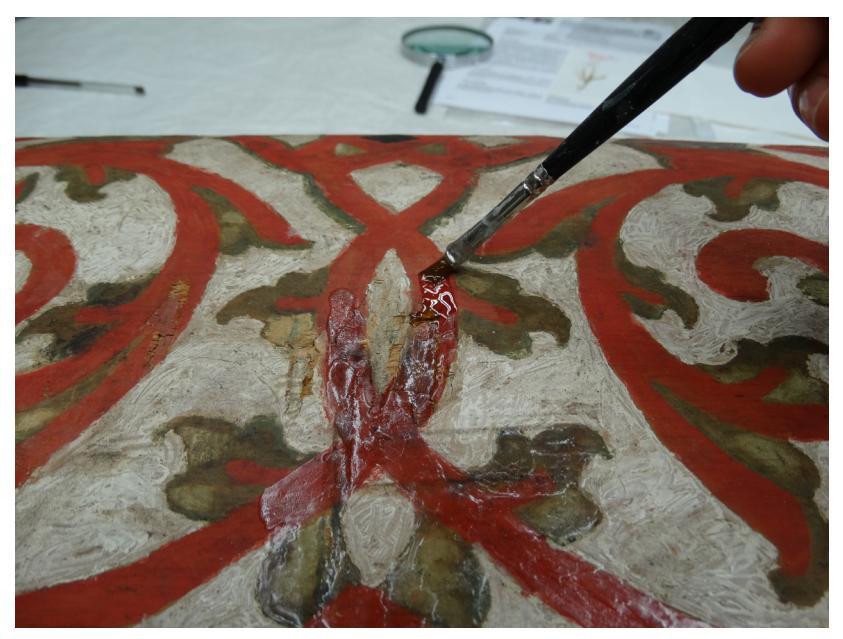
Figure 9 – Cyclododecane application above the water-soluble painting.

However, for the water gel cleaning of the white paint, it was decided to isolate the red, green and black paint layers due to their sensitivity to water. The fixative and temporary protective Cyclododecane¹⁰ was chosen to waterproof the paint (Boschetti & Borgioli, 2007).

The product was applied by brush in the molten state only on water-sensitive paint (Figure 9). The Gellan dowels were applied over the paint surface (Figure 10) and covered with polyethylene film and weights to exert a constant pressure in order to ensure maximum contact and a gradual release of water. After a twenty minutes application, the Gellan dowels were removed and the swollen dirt could be easily pulled off using cotton tampons moistened with demineralized water. The cleaning effectiveness is shown in Figure 11.

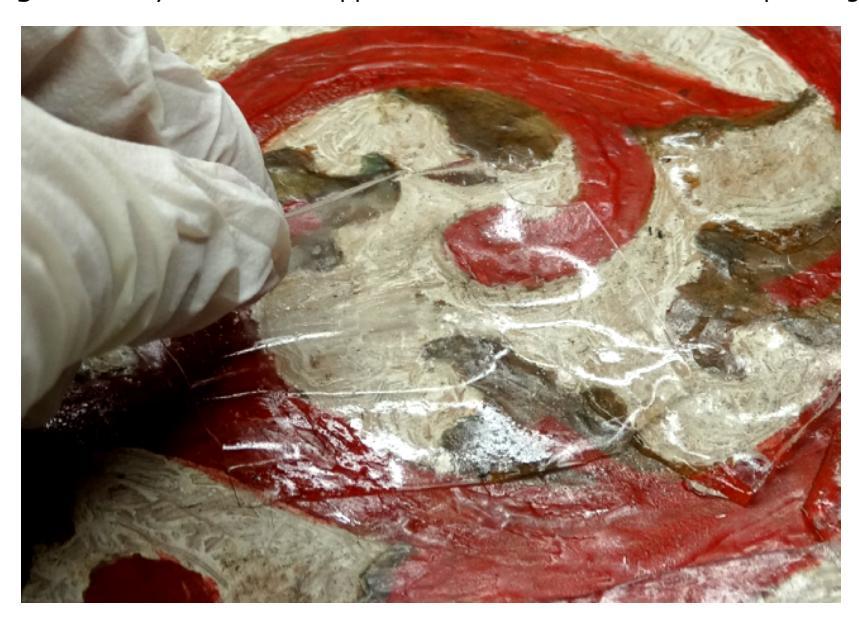
Figure 10 – Placement of Gellan® gum over the entire surface paint.

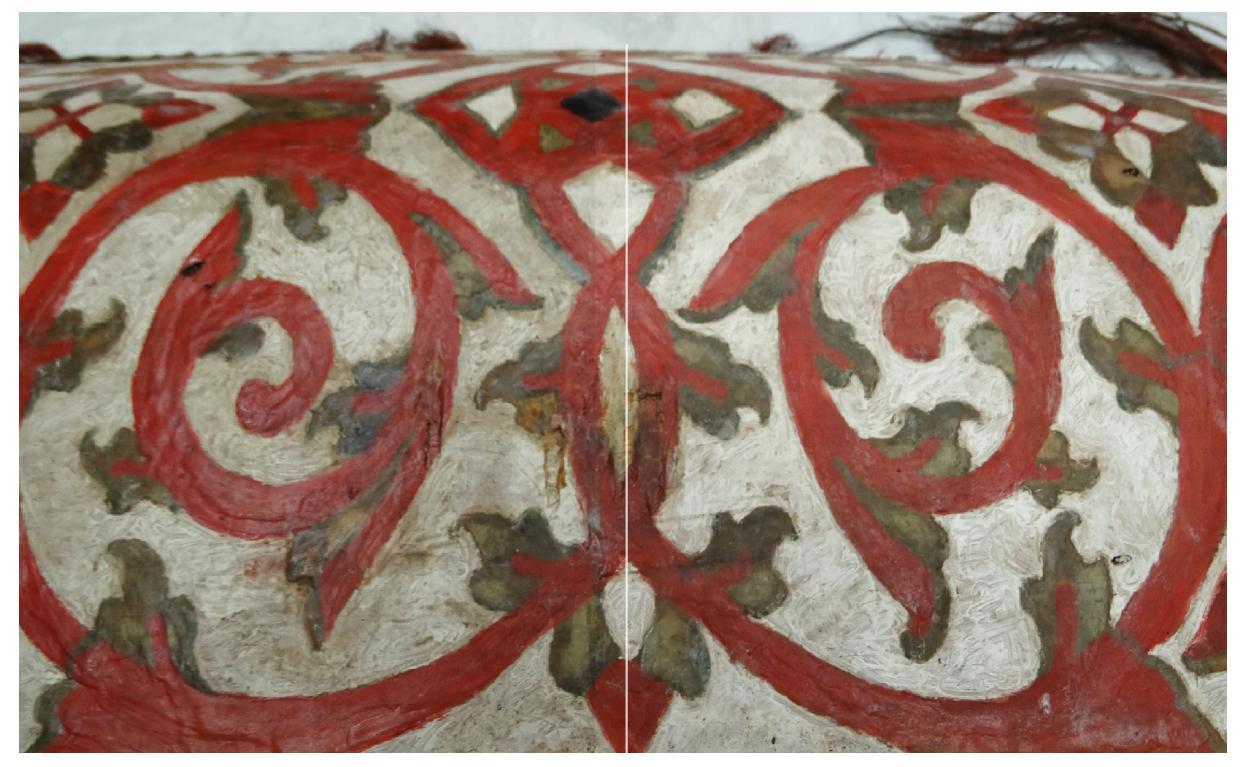
Figure 11 – Pictorial surface during cleaning.

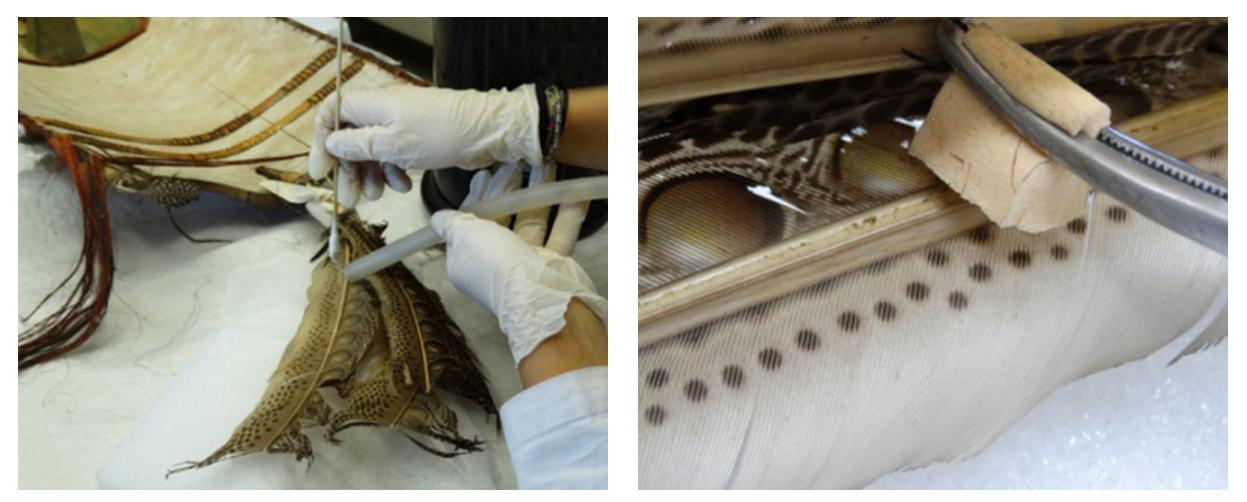
Figure 12 – Treatment on the feather's decoration: micro aspiration of dirt and dry cleaning with a *make-up* sponge above the rachides.

Regarding the feathers, the first operation was the dry cleaning to remove the coherent and incoherent deposits between the barbs and along the rachides (Gowers, 1972). The dirt has been removed by an aspirator with micro-spouts regulated at minimum power. Light pressure with a polyurethane *make- up* sponge was performed on the feathers for a more detailed refinement. Wet cleaning was performed by cold ultrasonic nebulized mister¹¹ and the dirt swollen by moisture has been removed using a dampened pad (Figure 12). The dirt has been removed with moistened swab alternating hydroalcoholic solution and deionized water with anionic surfactant¹² controlling the neutral pH¹³ (Green & Storch, 1988; Mason, 1990).

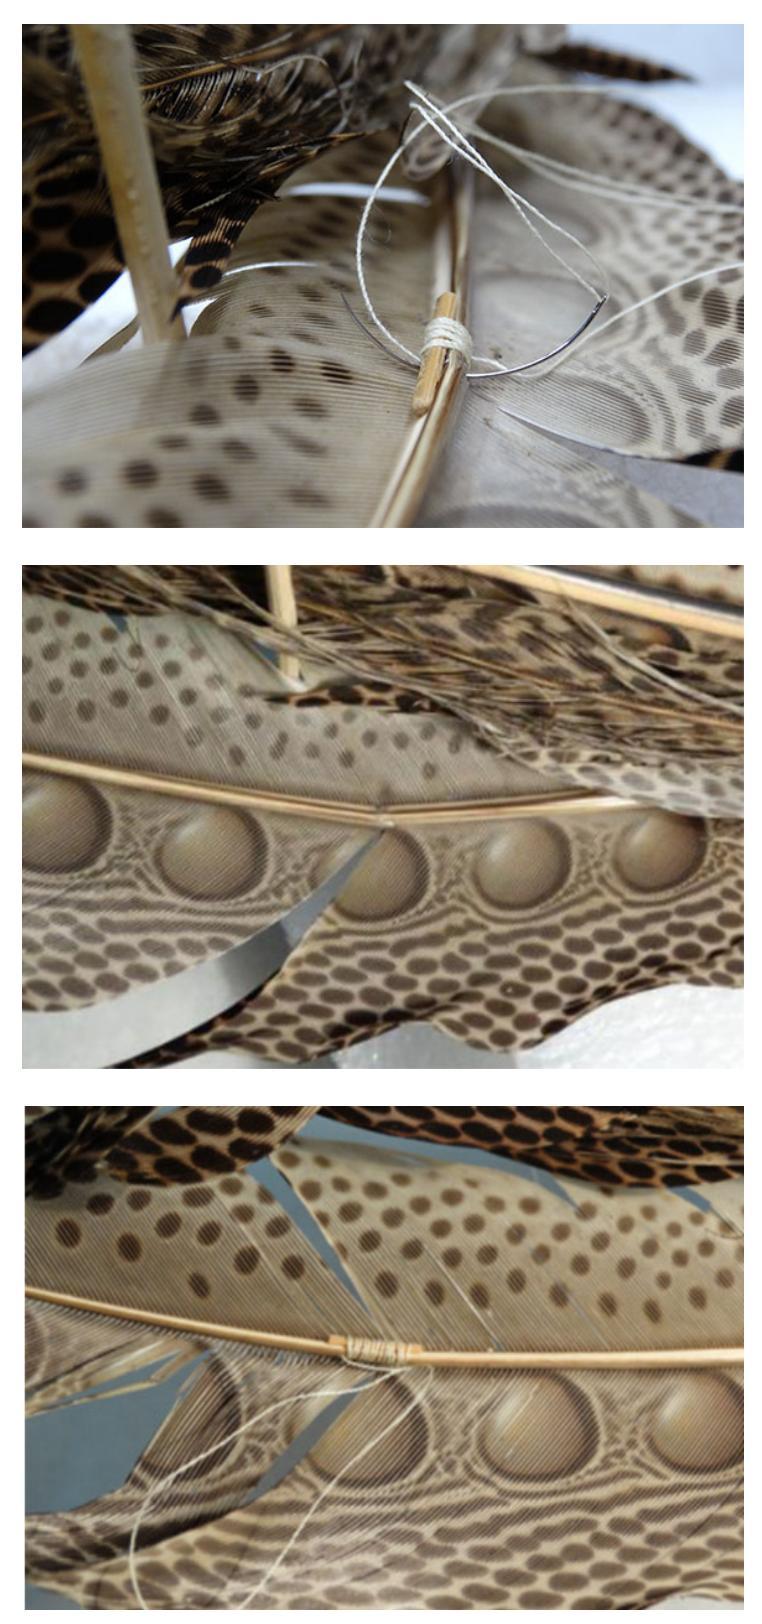
Figure 13 – Broken rachis seam by curved surgical needle and polyester thread, before and after sewing.

The rachis of the three feathers in the center were broken in several points. Therefore, the structural intervention was performed using needles and thread. In particular, a beige polyester yarn was inserted by means of a curved surgical needle and a wooden element was added to the sides of the seam to reinforce the spine (Figure 13). In one of the feathers, since the inside of the spine was hollow, a small wooden pin was inserted and fixed with nitro-cellulosic adhesive: the two ends of the spine of the feather were connected. As far as the broken quills are concerned, antique toothpicks made from quills and produced in the 1950s have been used. They were carved with a scalpel in order to obtain ad hoc shapes and then fixed by nitro-cellulosic adhesive (Figure 14). Since the barbules and beards were depolymerised, it was decided to perform a restoring treatment. Preliminary consolidation tests were conducted on a detached feather fragment in order to choose the best adhesive (Wright, 2002). The selected products were Funori® and Aquazol® 200, both in a water-alcohol solution, applied by using an ultrasonic aerosol nebulizer. The observation of the feather under a microscope allowed us to observe optical alterations that occurred on the surface of the feather. The Funori® did not alter the surface and gave strength and tenacity to the structure of the beards and barbules. Therefore, the consolidating treatment was performed with Funori®. After consolidation, before the consolidant evaporation and drying, the barbules were untangled by the insertion of thin entomological pins on a polyethylene support (Figure 15); they were left for about forty-eight hours, in this position.

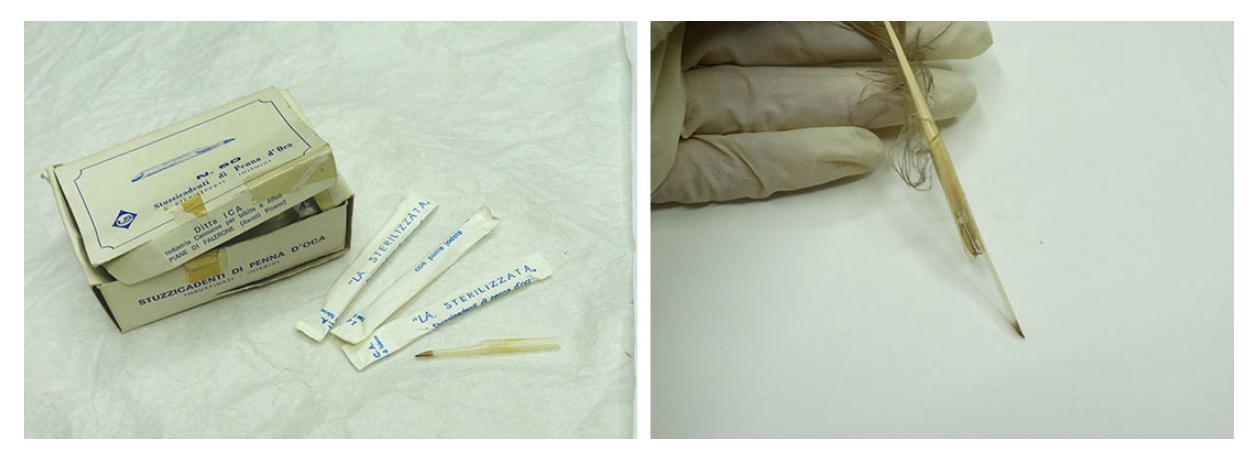
Figure 14 – Toothpick calamus datable of the 1950s: carving and inserting into the damaged feather.

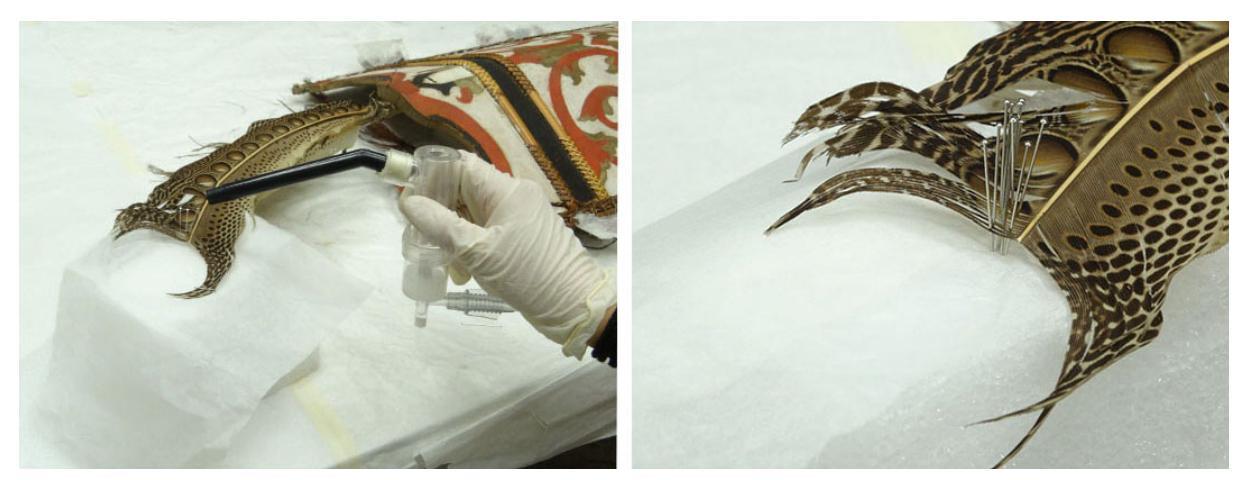
Figure 15 – Barbs consolidation by nebulizer and correct positioning of the barbs by inserting thin pins between them.

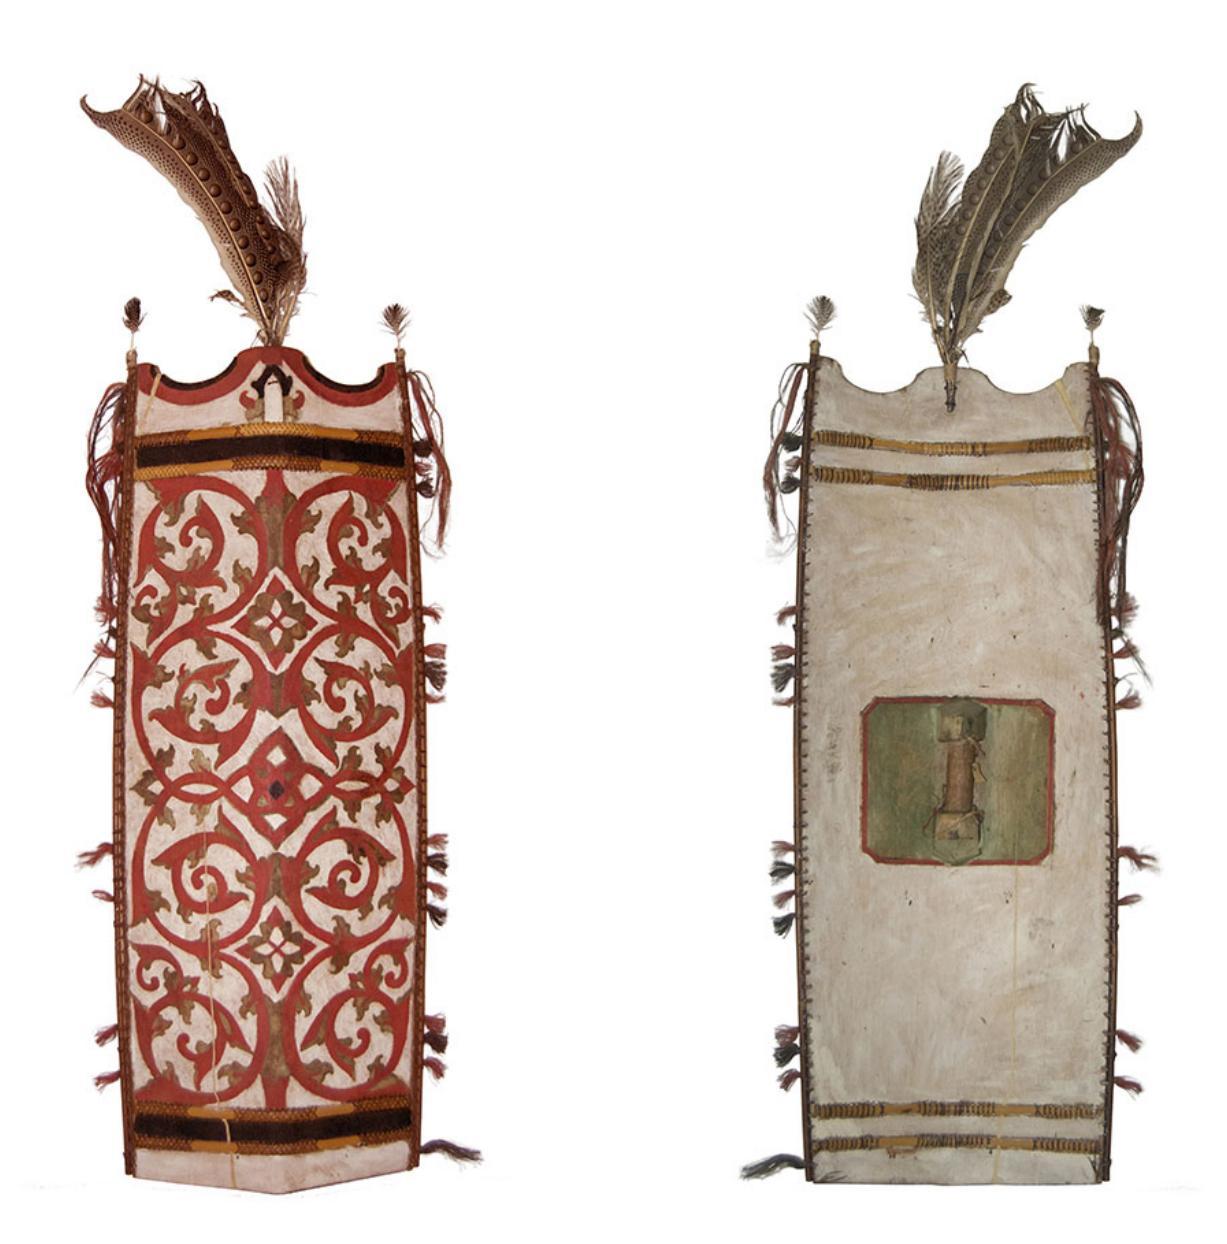
Figure 16 – Front and back side of the Dayak shield after restoration.

The research carried out on the materials and on the execution techniques had the purpose of expanding the historical-ethnographic knowledge on the technique of making Borneo wooden shields. The restoration intervention (see Figure 16) was based on the principle of minimum intervention respecting the material history of the object, trying to combine the needs required by its polymateriality, with the simultaneous safeguarding of those signs that represent the historical and cultural heritage of the artifact. The selected products were chosen on the basis of non-toxicity and compatibility with the materials of the object for a sustainable restoration with alternative materials and products. The use of Gellan® rigid gel was particularly noteworthy, even regarding its unusual use in the polychromy on a wooden support field: combined with the action of Cyclododecane as temporary protective agent during the selective removal of surface deposits on juxtaposed and otherwise sensitive areas, such methodology proved to be totally effective. The methodology adopted by using
